# Topic 5

# Case Studies

# Case Study No. 1

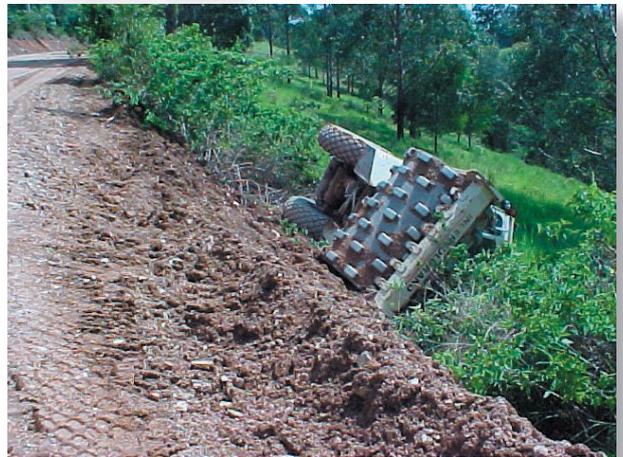
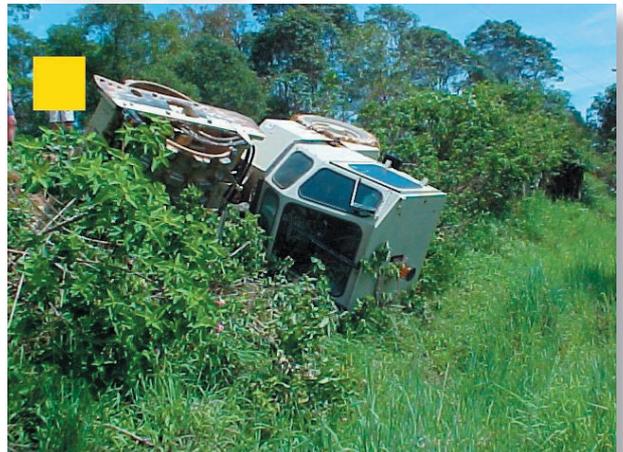
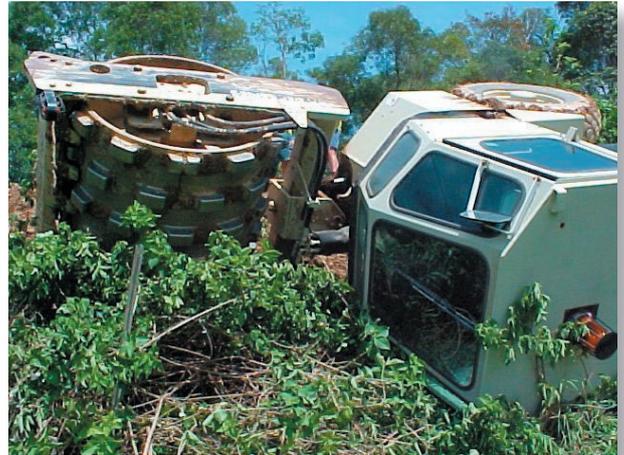
The uncompacted material under the wheels then subsided, and the machine began to roll over.

The machine came to rest on its side after rolling through about 100 degrees.

*Compactor Rollover*

- The rain the previous evening had made the material at the top of the batter very unstable, even though it was well outside the pavement area of the roadway.

- Even though a risk had been identified, there was no further discussion between the grader and compactor operators after the grader had stripped the wet material from the road and deposited it along the top of the batter.

- Prior to the incident, the compactor operator believed that he had been travelling at a safe distance from the edge of the batter.
- The council's work method statements for earthmoving equipment identify that roll-over hazards may exist, but do not give any procedures for controlling situations where a roll-over hazard has been identified.

- The roller operator and other plant operators attended a soils compaction course.
- An administrative structure was set up to ensure that all council road construction staff would, over a period of time, attend a risk-assessment course and undergo regular testing to ensure their skills remained current.
- Work method statements were amended to include procedures for control of situations where roll-over or other hazards have been identified.

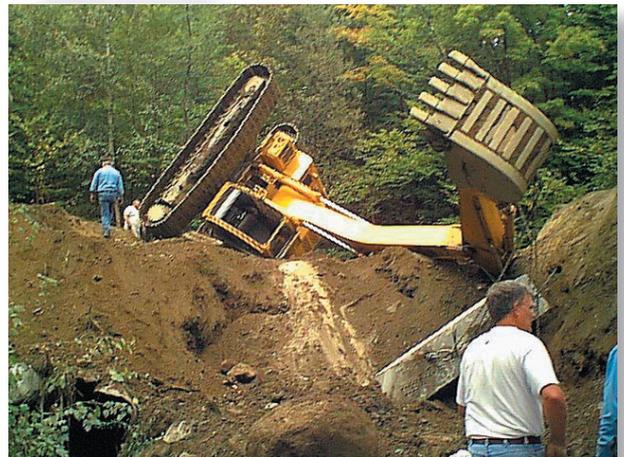
However, he misjudged the edge of the bank and the machine tipped onto its side. Fortunately, the operator was not hurt, as the machine had a fully enclosed cab that was positioned on the high side of the job. He was wearing a seat belt. However, when the machine came to rest, the boom blocked the lane that was open to traffic.

*Rolled Excavator*

- A temporary side track was constructed to allow diversion of traffic around the site, until the excavator could be moved.
- The downed machine was found to be operable. Another 20-tonne excavator (found working nearby) was used to right the downed machine. It was found to be operable, and was able to be driven off the bank by the regular operator.
- Repair of the excavator took three days.

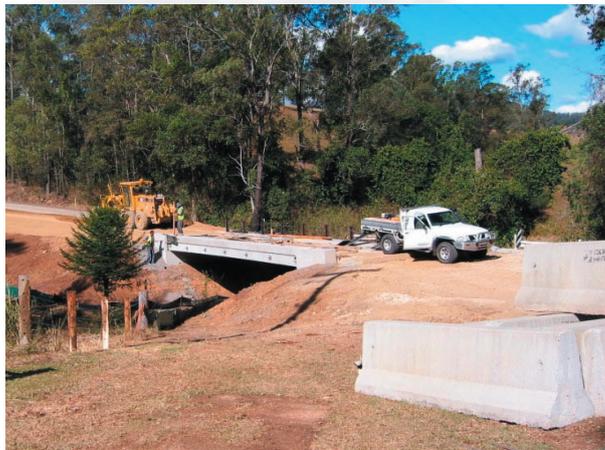
The barriers are approx. 3m long and weigh 2 tonnes each. They were being lifted by crane, with the road workers guiding the barriers into position by hand. The worker's finger was crushed when it became caught between one of the barriers and the truck gate.

*Concrete Barriers on a Roadworks Site*

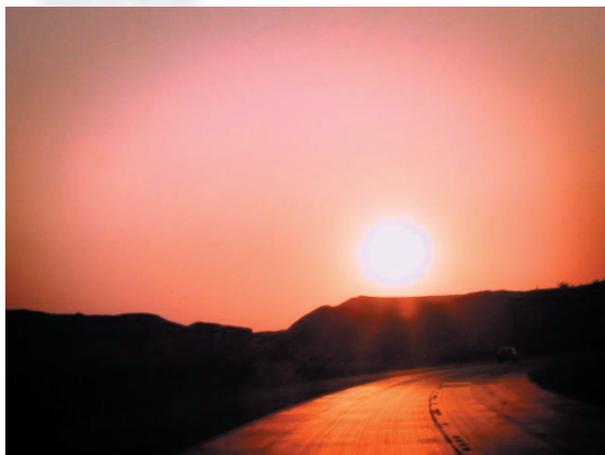
The incident occurred late in the afternoon in August. At that time of year, the sun is low in the sky for an extended period during the afternoon and the motorist was travelling westward.

*Road at Sunset*
